Located along the western coast of Kauai, the Mana Drag Racing Strip (MDRS) at the Kauai Raceway Park was originally constructed in 1971. This 40+ year old track, once home to taro fields and agricultural lands, was developed to help take racing off the streets and promote a safe environment for people to drag race their vehicles. The project site is owned by the Department of Land and Natural Resources (DLNR) and leased to the Garden Isle Racing Association (GIRA), a non-profit organization, who manages, maintains, and hosts events with the help of volunteers and donations. Races held at MDRS are family oriented community events that draw families and individuals both young and old from across the island to watch and participate in drag races. Junior drag racing competitions allow youths between the ages of 8 and 17 to get involved and learn about drag racing while Top Gun races provide a place for the fastest cars in the state to show off their muscle. As one of the few drag racing strips left in Hawaii and one of only two NHRA member tracks in the state, the MDRS is an important part of the motorsports community, Kauai, and the State of Hawaii.

#### MANA DRAG RACING STRIP IMPRO

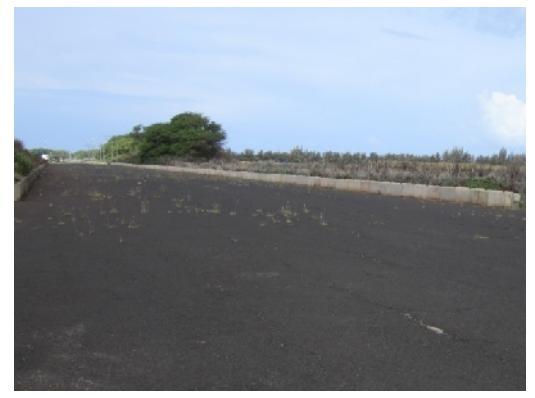
Figure 1 – Existing Track Condition: Grass/Weeds growing through numerous cracks.

In addition to the safety conditions of the track, the 40+ year old pavement showed its age. Pavement cracking accelerated by the hot and dry climate at Mana was prevalent throughout the track. Grass and weed growth through the cracks required continues maintenance and promoted wear and tear and at times damage to vehicles.

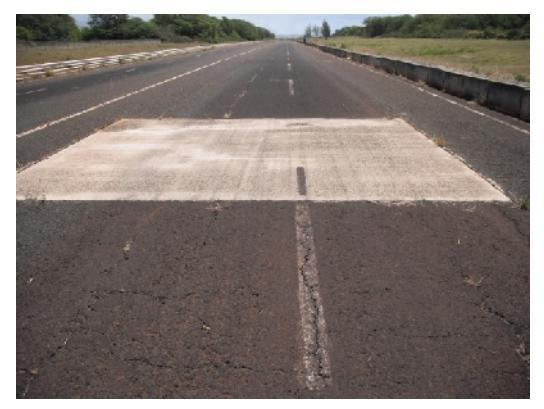
Figure 2 – Existing Track Condition: Concrete patches along track length.

Throughout its 40+ year life, the track also experienced pavement settlement in several locations. Concrete patches used to repair the areas created varying pavement conditions. At high speeds, the change in pavement conditions could potentially cause vehicles to lose traction or move erratically. Drivers put in those situations where required to make sharp corrections which could cause them to veer into the barriers or adjacent lane putting the other driver or public at risk.

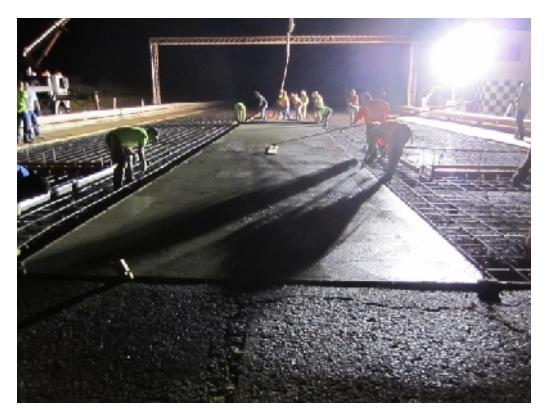
Figure 3 – Pouring of concrete launch Pad

To eliminate perpendicular cold joints and the possibility of dissimilar movement of the concrete slabs, each lane of the concrete launch pad was designed to pour monolithically. Given Mana's hot and dry climate, the contractor quickly discovered that pouring concrete during the day would be difficult. Under the collaboration with DLNR and TLCG, the contractor adjusted his schedule to pour all concrete slabs at night. Preparation for the pours started in the late night hours with the concrete pour occurring through early morning to ensure workability of the concrete. Work lights were necessary for the contractor to complete their work, but location of the project near the flight path of endangered birds posed a potential risk. TLCG coordinated with the U.S. Fish and Wildlife service to ensure proper precautions were taken and minimize the possibility of injuring the seabirds.

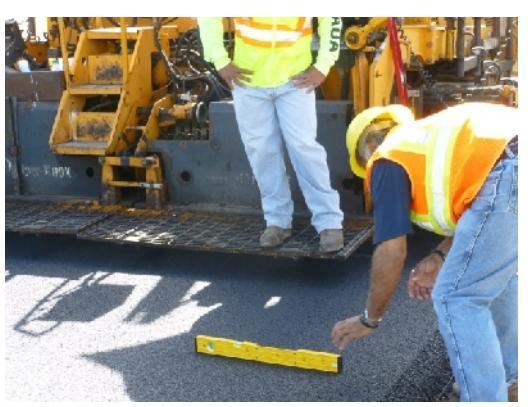
Figure 4 – Checking loose AC with 3-foot digital level prior to rolling.

With the strict NHRA guidelines and tight tolerances not typically found in roadway pavement construction, the contractor needed to implement additional quality control measures. Topographic surveys were conducted during multiple stages of construction to ensure the strict tolerances were met. Surveys of the subbase, base course, and finished pavement were assessed in 3D models to ensure design specifications were met. Verification with a 3-foot digital level and 10-foot straight edge was also done to meet specification requirements.

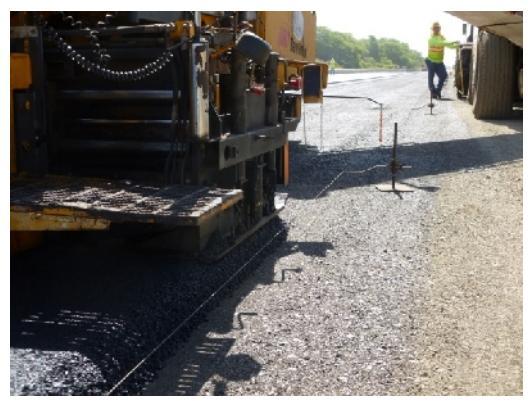
Figure 5 – Pavement installed using the tried and true "String Line" method

Paving to meet a 1% maximum cross slope is not the industry standard and is difficult at best. The paving contractor decided to utilize the tried and true "string line" method of pavement installation. In addition, checks during various stages of the paving process were done. A straight edge and tape measure was used intermittently to check the asphalt concrete lift before compacting. The contractor also used the 3-foot digital level as he laid the asphalt concrete to ensure that even the loose layer was close to the required finish specification.

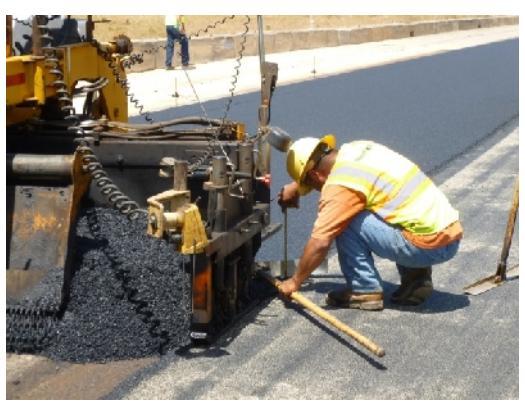
Figure 6 – Verifying pavement thickness prior to rolling.

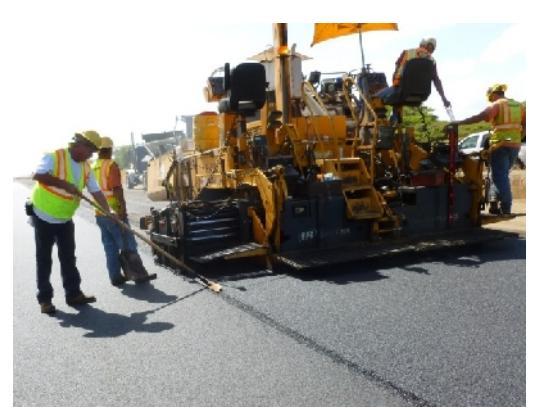
Figure 7 – Good practices result in a good product. Contractor cleans the edge of the pavement joints before rolling.

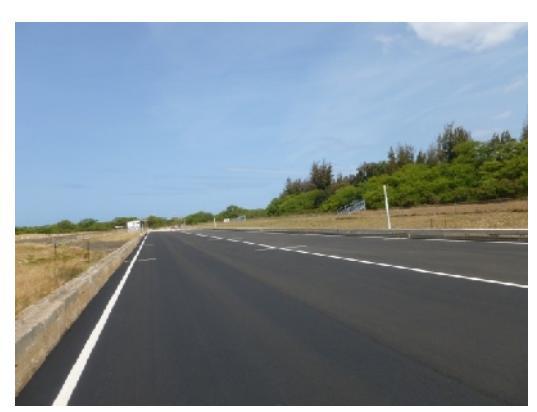
Figure 8 – AC pavement joints kept at mid-lane to minimize impact of vehicle tires.

To minimize the impact on the vehicle traction and ride and to help promote longevity of the pavement, the asphalt concrete pavement was laid with joints at mid-lane.

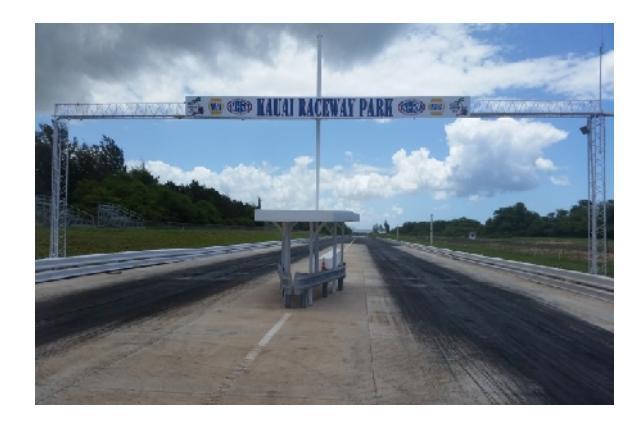
Figure 9 – Completed Track Improvements (Concrete Launch Pad)

Prior to the project, the aging track surface was in dire need of repairs and posed safety concerns for the racers and public spectators. The track improvements at MDRS were a success. The concrete and asphalt pavements were installed and met the strict NHRA requirements. MDRS was able to retain its NHRS member track designation.
